Street Farmhouse : 230 Canterbury Road

No. 230 Canterbury Road is the right-hand part of the original timber-framed farmhouse of Street Farm. The original layout of the house was a large open to roof hall in the centre of the building built c. 1450-1500. In c. 1600 a pair of inglenook chimneys were inserted and by 1720 the whole building had been divided into three dwellings.

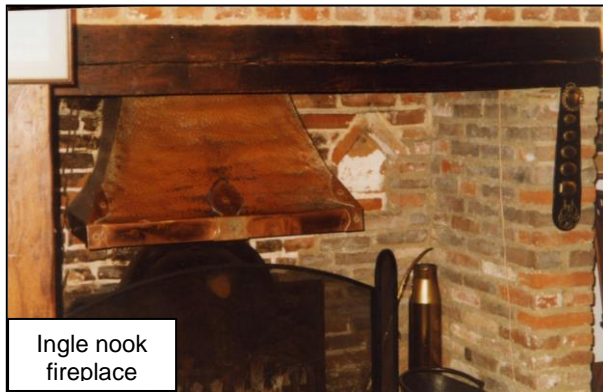
The huge beams, which run from front to back of the room, are original ones and still contain numerous different carpenters' marks. Two of the doors are very old and have handmade hinges, each of which has the blacksmith's mark [**F.H.**] enclosed in a square, stamped into them. There have been two

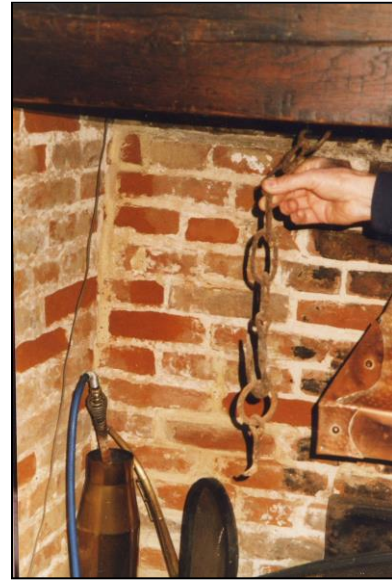
The loft above also contains huge smoke-blackened timbers, indicating that there was once a central, open fireplace down below and that the smoke then found its way up into the roof space and out through the thatch and later, the tiles and the two gablets at each end of the enormous roof. When the great fireplaces and chimneystacks were inserted in the 17th century, this must have made a real difference to the quality of life that was led in the old house. The front door into the house could well have been altered from a passage entry into a lobby-entry at this date.

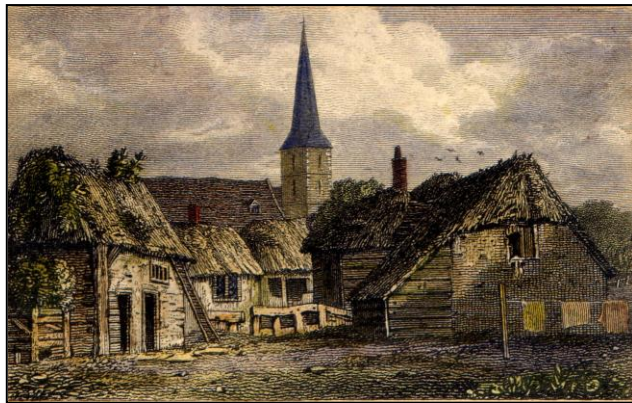
Street Farm barns & cottages 1845

As can be seen from the details noted during these visits, the house is certainly considerably older than the listing states. This was the farmhouse that belonged to what was known as Street Farm, whose land stretched up to the edge of the old churchyard. Barns on this farm are shown on an old etching of about 1845. This etching also shows the end of the pair of cottages now known as Street Farm Cottages.
