Rossetti Court, Lyell Road, Birchington

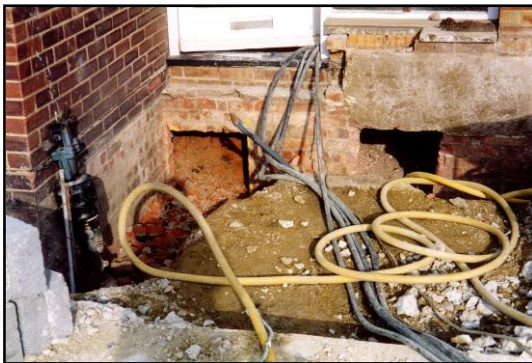
Before the railway came, the site had held a seed mill in the centre of the plot. This was a timber structure on a brick base. Following its demolition and the dumping of the soil from the

station site, the only buildings that occupied the site were various wooden units – one of which can be seen in the aerial photo of 1938. So nothing of any great weight had been put on the land to help compact the ground.

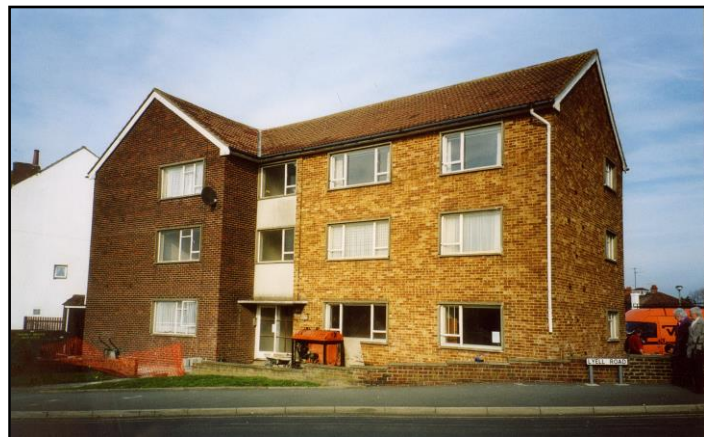
Rossetti Court 2004

Because the builders were unaware of these facts, they did not make allowances for the extra deep and sturdy foundations that were needed in the circumstances. During the late 1990s, cracks began to appear in the plaster of the walls inside the flats. Then the cracks became visible on the outside brickwork. Eventually, in c. 2001-2 a survey was carried out and the residents were asked to leave the building while repairs were made. These were carried out during February and March 2004 – see photos taken in March that year. Finally the residents were able to return to their homes once more, safe in the knowledge that their flats were now on very solid foundations.
